Manhole Inspection Summary

Manhole # S23II_040MH

Insp Date: **9/28/07 2:25 PM**

Location Address: **2206 PENNSYLVANIA AVE**

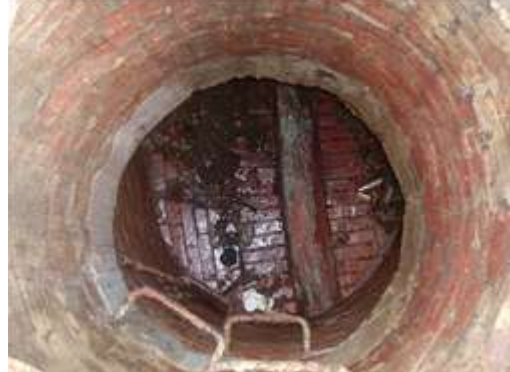
Top View

Corroded steps. Bench debris.

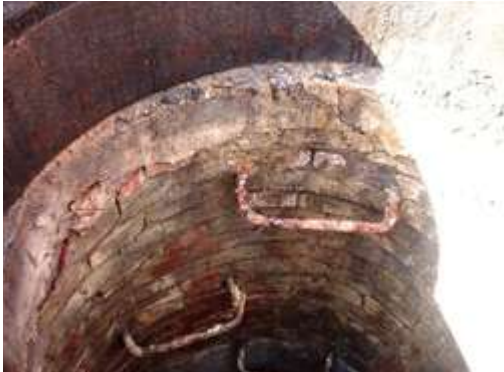
Defect

Frame leaks. Frame offset. Adjustment deterioration and infiltration

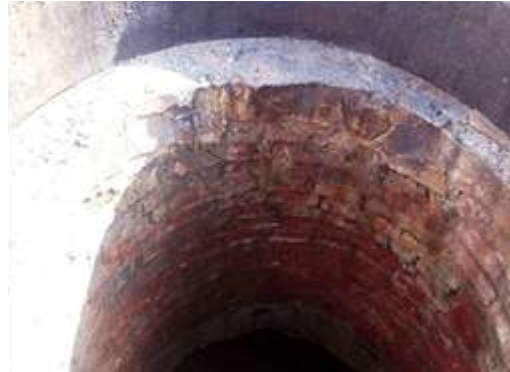
Defect

Frame leaks. Frame offset. Adjustment deterioration and infiltration.

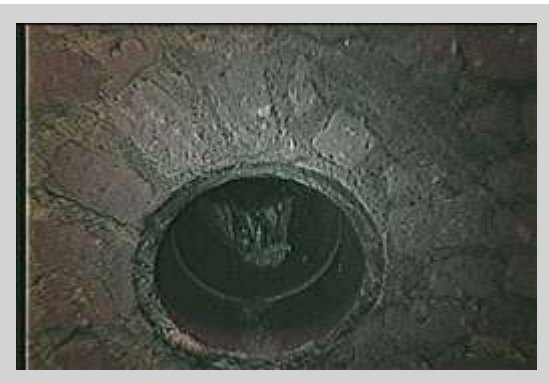
8 in. Circular Gravity Sewer Pipe In @ 6 O'Clock

Infiltration: **Evidence** Pipe Seal Cond: **Cracked**
